Q INSIDE® SAFETY TECHNOLOGY

FACTS FOR RADIOLOGISTS & MRI TECHNICIANS

Patients with Motiva Implants® with Q Inside® Safety Technology can be scanned safely with 1.5- and 3-Tesla (T) Magnetic Resonance Imaging (MRI).¹

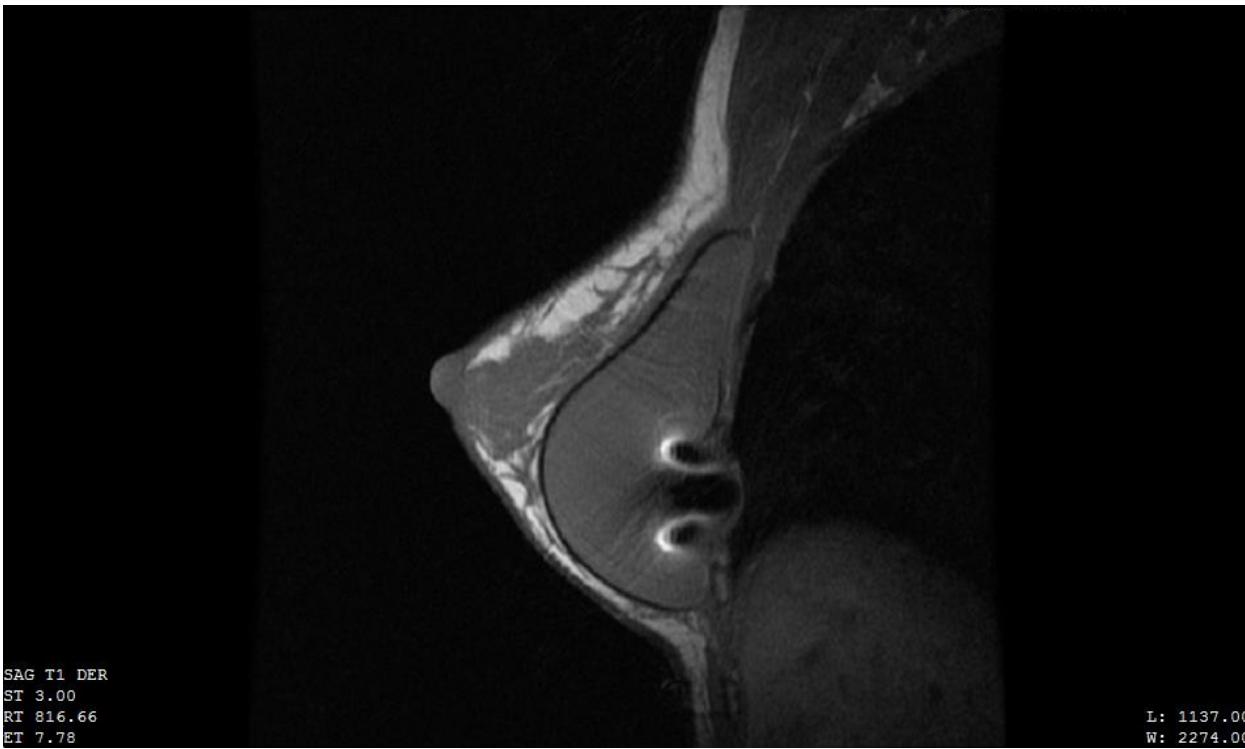
Image 1. MRI – T1-weighted sequence of the right-side breast showing the microtransponder-related artifact.

In non-clinical testing, the image artifact caused by Q Inside® Safety Technology extends approximately 15 mm from its location within the implant when imaged using a gradient echo (GRE) pulse sequence and a 3-Tesla MRI system.⁵

When patients undergo MRI, a small area posterior to the implant is obscured (see images 1 and 2). The mammary tissue, however, is fully visualized because the dimensions of the artifact do not extend beyond the anterior implant limit.

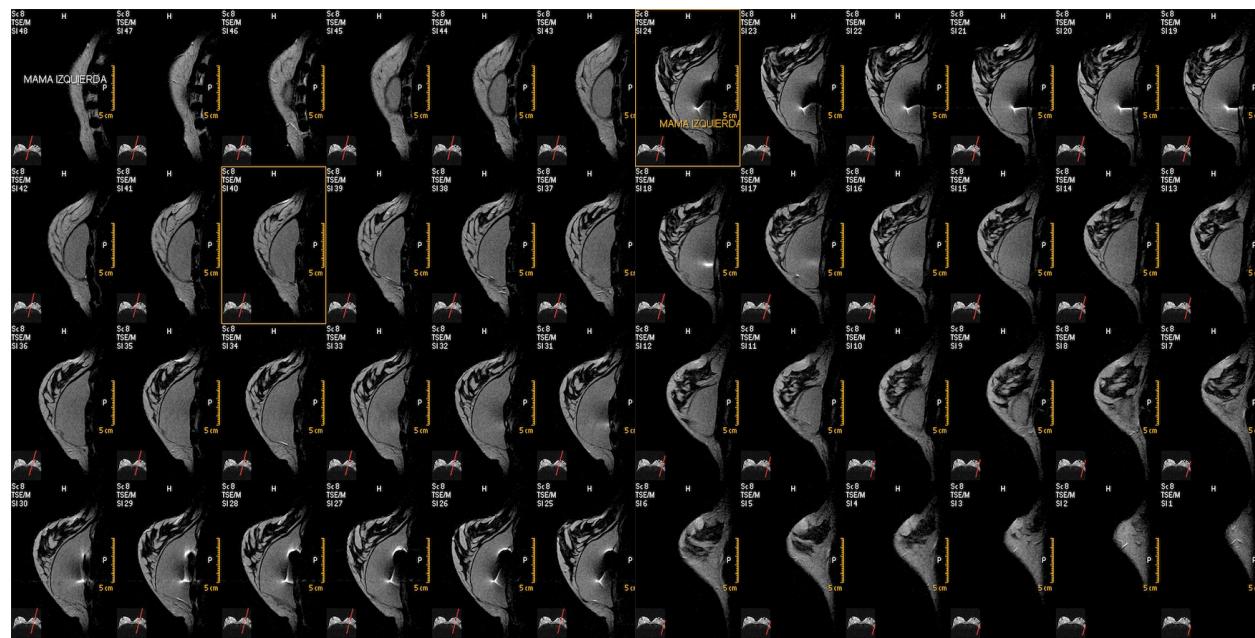
Image 2. MRI of the left-side breast showing the microtransponder-related artifact in approximately 25% of the images (12/48).

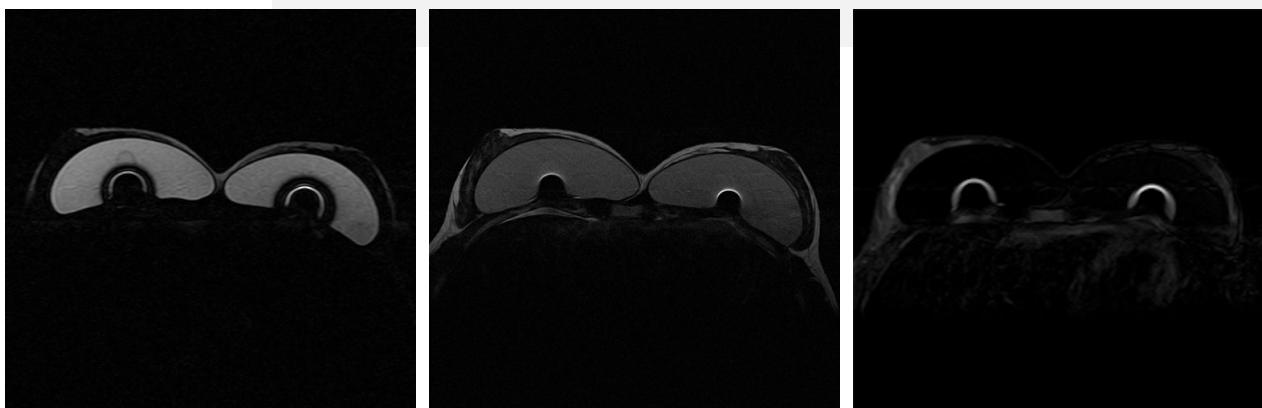
Image 2. Axial "silicone only", T2-weighted, and T2 SPIR (spectral pre-saturation with inversion recovery) sequence comparison showing the microtransponder-related artifact

- Strategically selecting the pulse sequence (see image 3)
- Reducing slice thickness to 1 or 2 mm
- Reducing the echo time (ET)
- Increasing the receiver bandwidth (range of frequencies collected per pixel)
- Applying artifact reduction advanced software, if available (depending on MRI vendor)
- When possible, utilizing inversion recovery sequences (short tau inversion recovery, or STIR) for fat suppression
- Acquiring GRE or fast GRE for contrast-enhanced MRI with gadolinium when screening for breast cancer

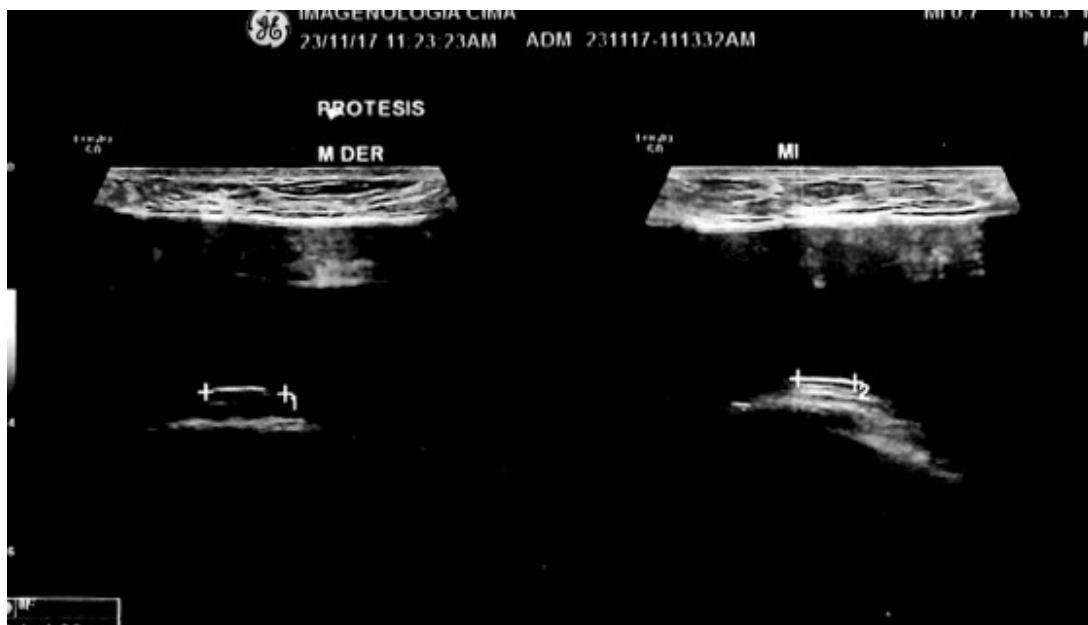
Image 4. Breast ultrasound showing the RFID in both right and left implants.

Sonographically, the microtransponder becomes visible inside the implant mass due to its good echogenicity. Aside from making its presence evident inside the implant, Q Inside® Safety Technology will not interfere in any way with such an examination, its results, or a consequent diagnosis (see image 4).
